IMPROVED ALUMINIDE COATINGS for NICKEL-BASE ALLOYS

M.A. Levinstein and J.R. Stanley

GENERAL ELECTRIC COMPANY

CONTRACT NAS 3-11160

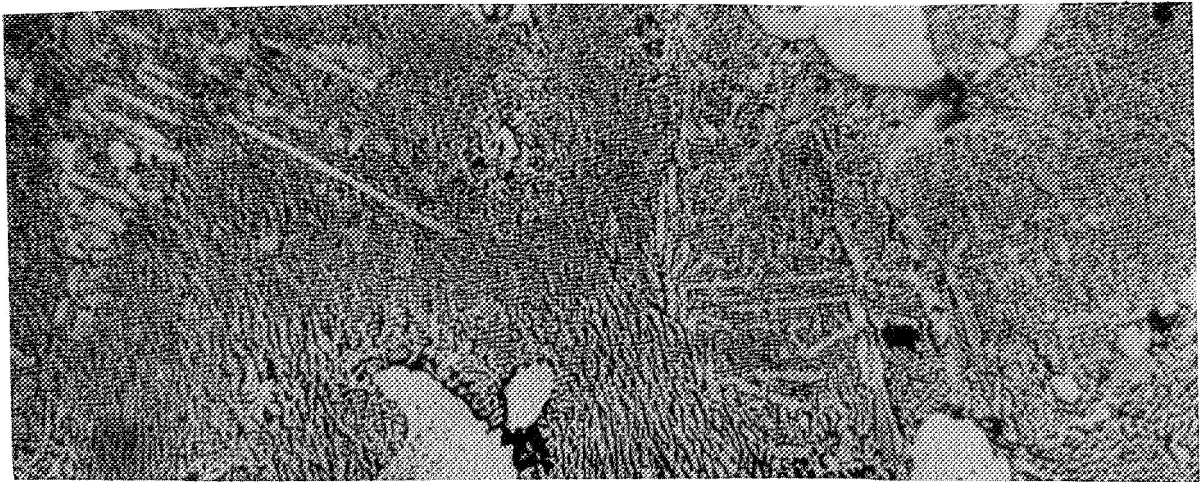
Figure 13. NASA VIA Alloy Structural Changes After 300 Hours in Laboratory Static Oxidation Test (Etched 500X).

The continued overheating of the lower trailing edge in the EPPI test prompted an investigation of the temperature being experienced in that area. A study was conducted comparing the metallographic structure of the base alloy after exposure in the EPPI rig with bare specimens exposed statically at several temperature levels. Temperatures of 2050°F (1394°K) and 2150°F (1450°K) were selected for exposure times up to 300 hours. Sections were taken every 50 hours for metallographic examination and compared with a bare 360-hour EPPI specimen. The static oxidation effects at 2050°F (1394°K) after 300 hours are shown in Figure 13, in comparison with the leading, center, and trailing edge sections of the 360-hour bare EPPI specimen, Figure 14. Note that the coarsening of the gamma prime structure in the static test at 2150°F (1450°K) (Figure 13, bottom) is virtually the same as that of the EPPI center airfoil section (Figure 14, center). The grosser coarsening at the lower trailing edge section of the EPPI specimen (Figure 14, bottom) would indicate a temperature in excess of 2150°F (1450°K). On this basis, it is evident that the major portion of the weight loss sustained by the specimens in the EPPI rig is attributable to the localized over-temperature condition.

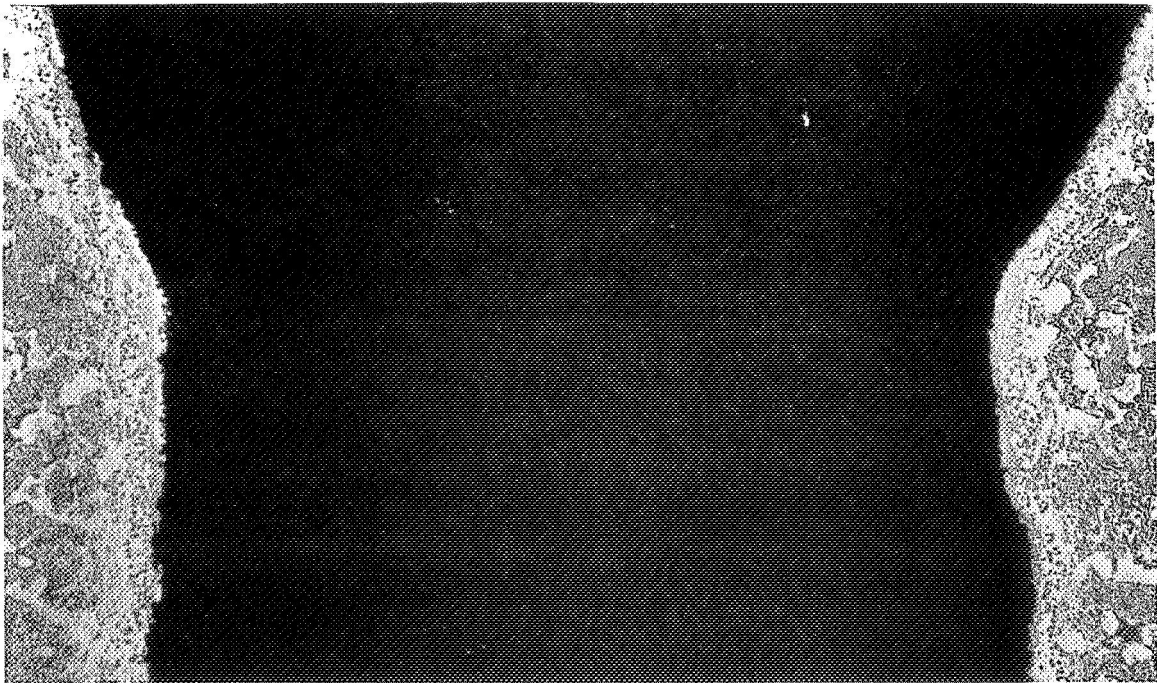
Maximum Depth of Coating Protection - 0.250 Inch (0.63 cm)

Figure 36. NC11-A-S1 Coating in 0.040-Inch (0.10 cm)-Diameter Hole After 995 Hours at 2000°F (1366°K) (Etched 100X).

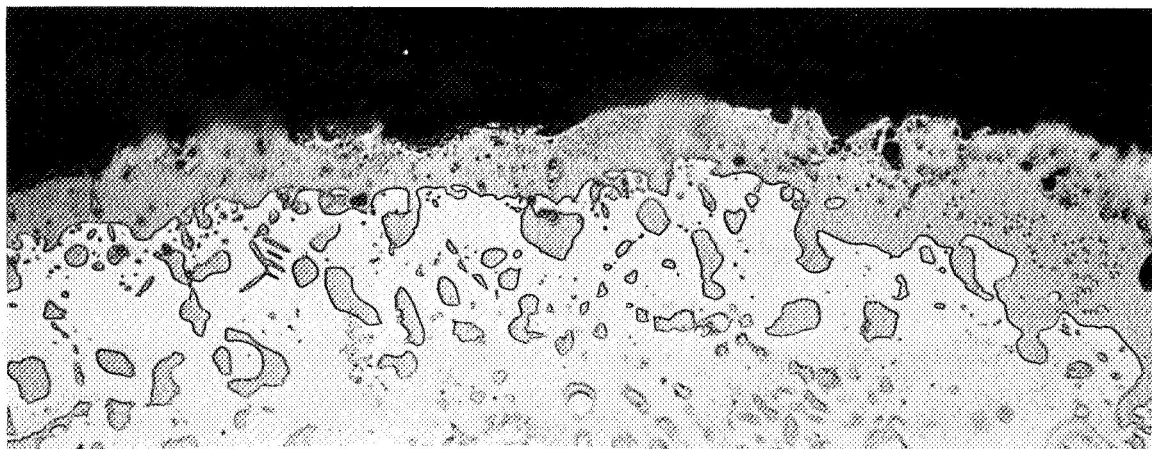
Figure 51. NC11-A-D1 Coating at 1.0 Inch (2.54 cm) Below Tip After 2000°F (1366°K)/2000-Hour Burner Rig Test (Etched 500X).

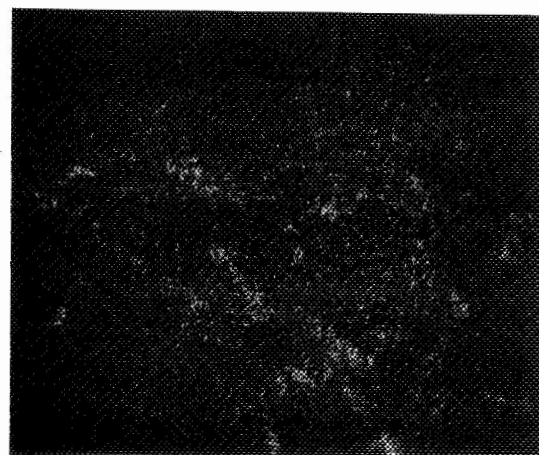
W

Figure D-6. Electron Microprobe Scan of NC11-A-S1- Coated NASA VIA Alloy for Distribution of Principal Elements in Coating and Matrix After 1013 Hours at 2000°F (1366°K) (360X).
